F-1-182
Doubs Survey District
Private

F-1-182
Doubs Survey District
Doubs
Frederick County

historic Doubs Survey District

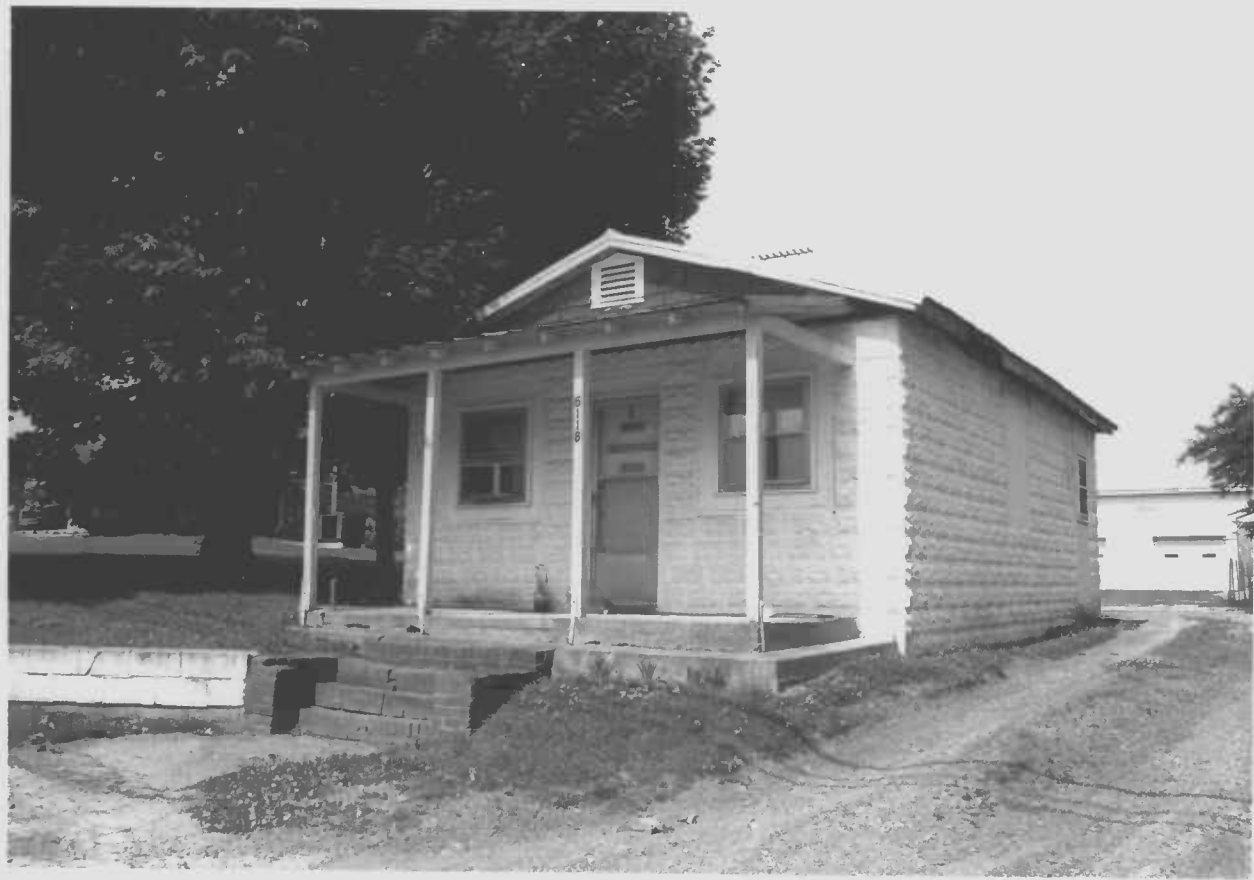
6/30

5118 Douglas Rd., southwest elevation

Davis Store, 5118 Doubs Road: The one-story building erected about 1940 by Elmer Davis as a store is now a residence. It has rusticated concrete block walls and a shed porch over the three-bay southwest elevation. The windows are modern and the door is also a replacement. It operated as a general store until the 1960's.

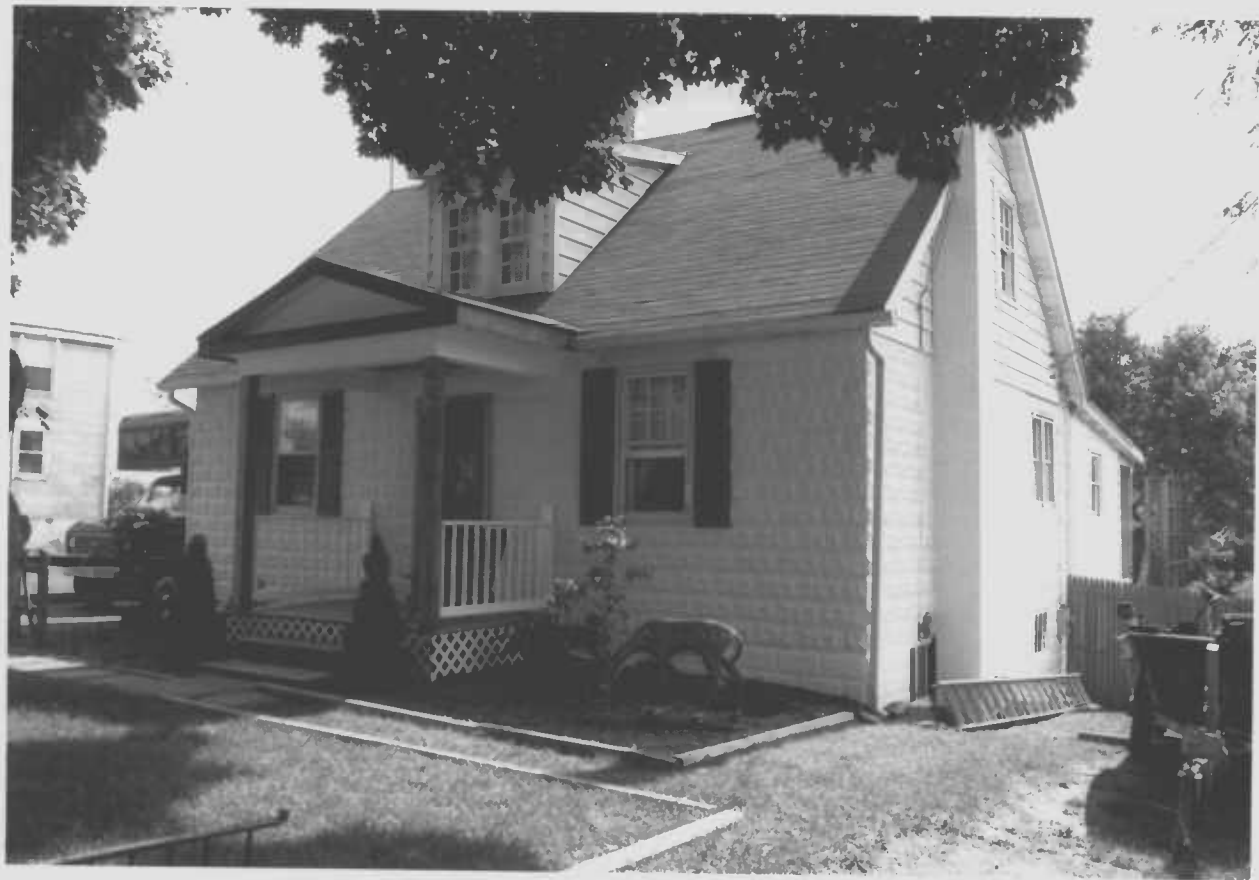
10/30

5125 Doubs Rd., northwest corner view

Concrete block house, 5125 Doubs Road: The 1-1/2 story house has walls of rusticated concrete block, currently painted yellow. The three-bay facade has a center entrance with a modern entry porch. A shed dormer projects from the composition gable roof above the entry porch. An exterior concrete block chimney is on the north elevation. Modern additions are located on the west elevation. The house was probably built about 1945 by Millard and Edna Hickman. It is unique in the Doubs Survey District as the only concrete block dwelling.

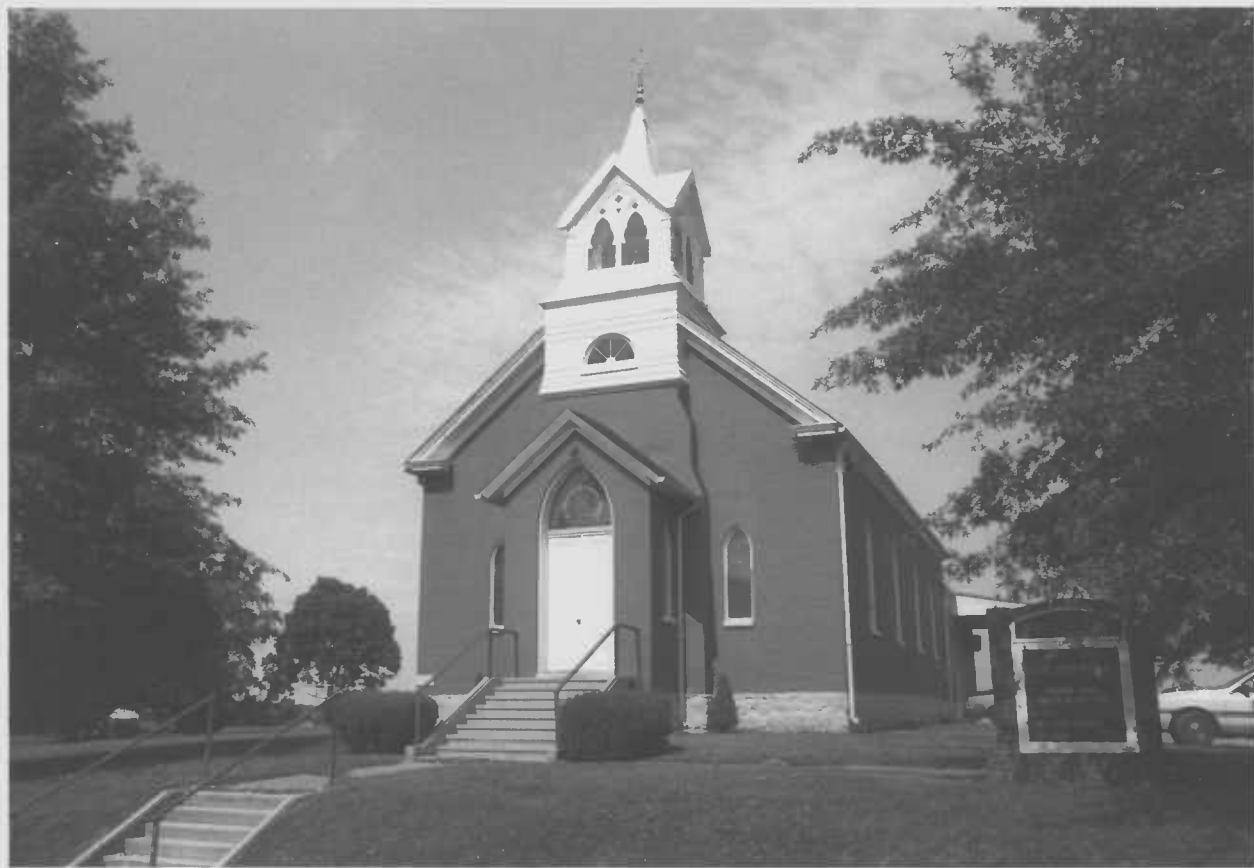
12/30

St. Mark's Evangelical Lutheran Church (F-1-95)

South elevation

St. Mark's Evangelical Lutheran Church: Built in 1882, according to a dated stone at the northwest corner of the foundation, the one-story brick church has a projecting entry foyer in the three-bay southwest elevation flanked by Gothic arched narrow stained glass windows. Brick infill around the windows suggests that the projecting entrance was added to the building after the initial construction. The double doors have an arched stained glass transom. The foyer is in front of the base of the bell tower, which has a shingled base. The steeple has a truncated appearance, suggesting that the tower may have been altered, possibly after damage by a storm. The earliest known photograph of the church, taken in the early 20th century prior to the construction of the concrete front steps in 1938, shows the present belfry appearance. The gabled belfry sits on top of the shingled section with a short steeple terminated by a weathervane. The gable roof of the church is covered with composition shingles. The north and south elevations have 4 bays with Gothic arched, stained glass windows. A concrete block addition on the rear was built in 1953 according to a plaque on the south elevation.

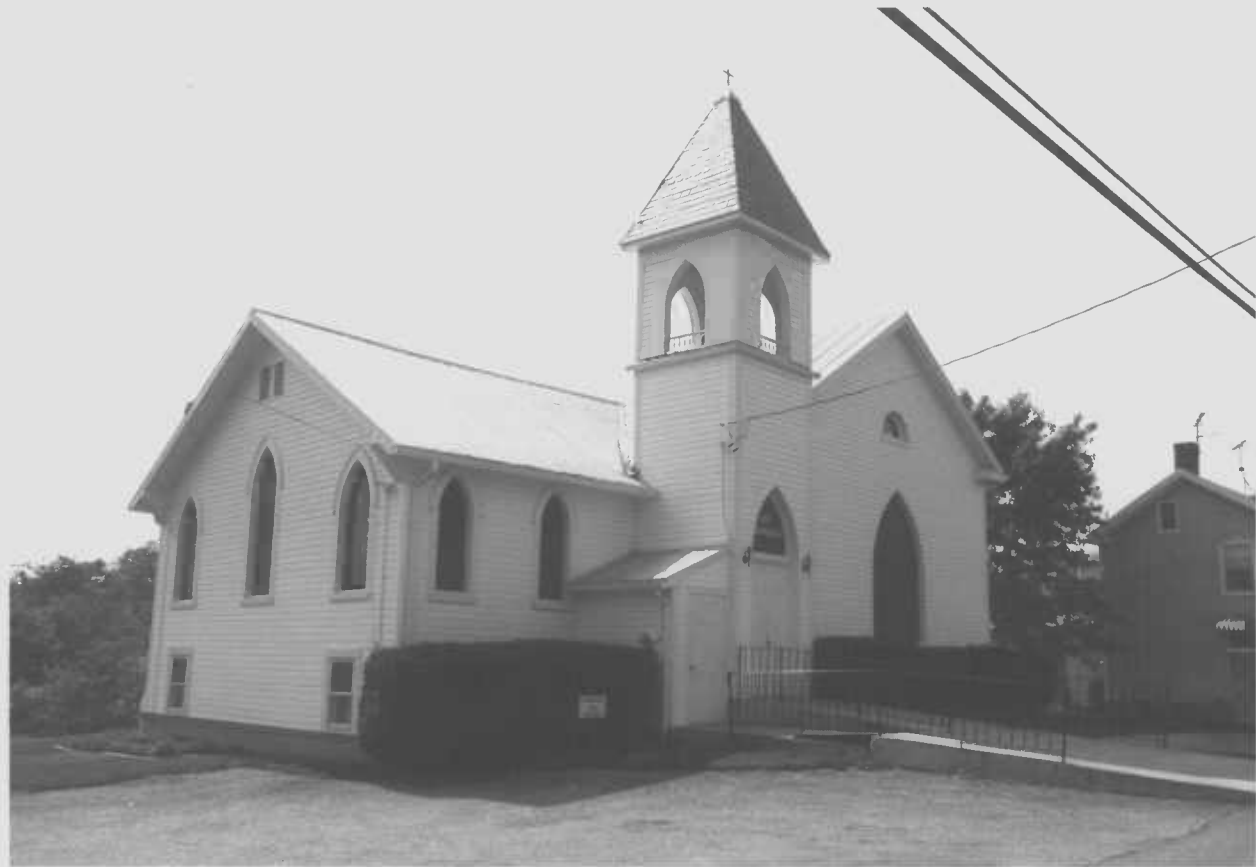
13/30

Doubs Methodist Church (F-1-96) north east
corner view

Doubs Methodist Church (F-1-96): Located directly southwest across Doubs Road from St. Mark's Lutheran Church, the frame Methodist Church was built in 1879, with a dated stone in a free-standing sign in front of the building. The stone was removed from the original stone foundation of the building when it was replaced with concrete block. The church is L-shaped, with a gable front facing the road adjoined by a perpendicular section to the south. A bell tower is in the angle between the two sections, with the entrance through the base of the tower. The windows have Gothic arches with stained glass, and a stained glass arched transom is above the double entrance doors. The exterior is covered with vinyl siding and the main roof is covered with corrugated metal. The hipped roof of the belfry is patterned slate.

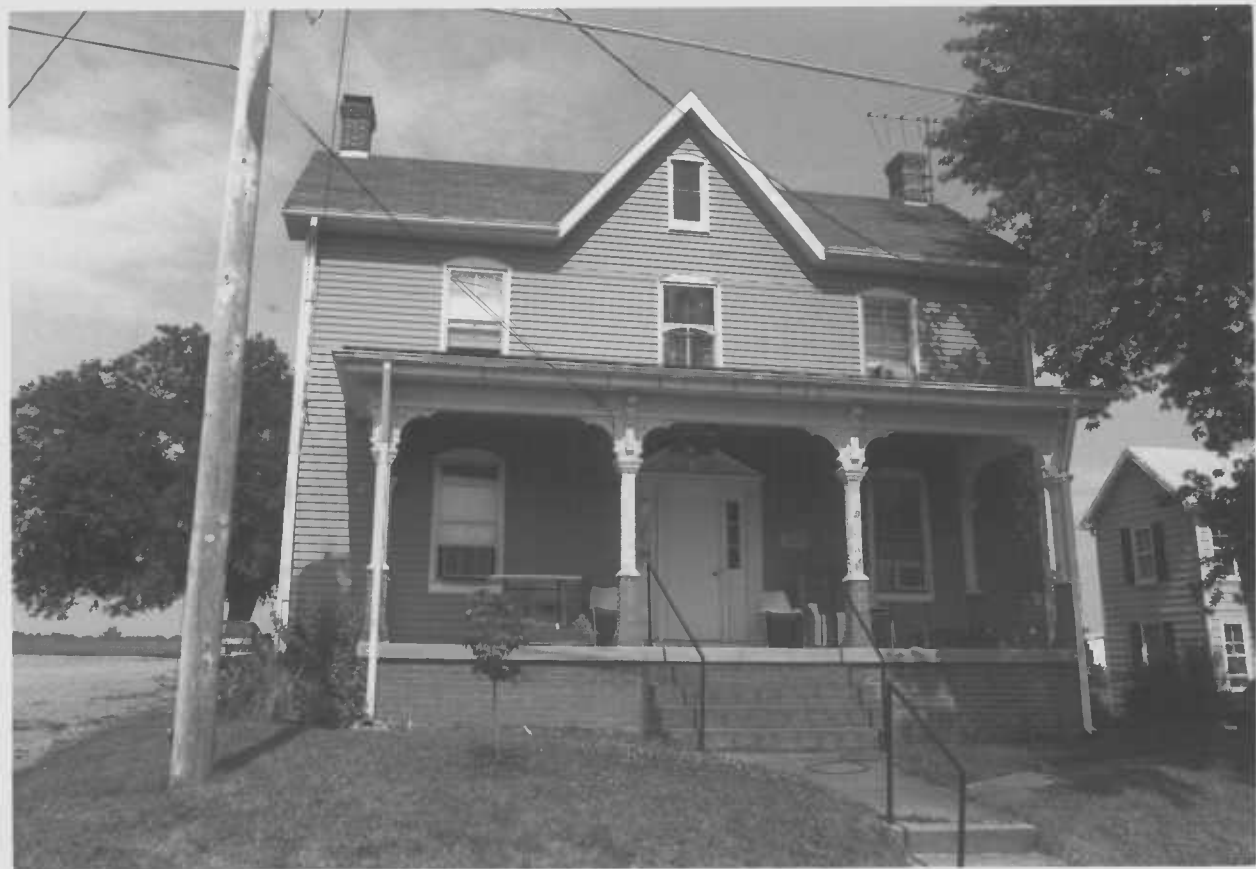
14/30

Lutheran Parsonage^{F. 1-103}, southwest elevation

Lutheran Parsonage (F-1-103): The parsonage is located south of St. Mark's Lutheran Church. It is a frame, two-story residence with a central cross gable and a one-story porch with brackets. The three bays have segmental arched openings. Photos dated 1978 show that the house originally had a patterned slate roof, a dentil cornice molding, and a segmental transom above the door. The exterior was covered with asbestos shingles. At present, the house has a reproduction broken pediment door surround and modern door and vinyl siding. The roof is covered with composition shingles and the dentil molding has been

removed. The sash remains 2/2. Interior end chimneys rise at the north and south gable ends. A two-story rear wing extends from the east side of the house. The parsonage was built about 1888, based on land records. It is representative of several dwellings of the same general type and style, with cross gables and one-story porches on three-bay facades. As it is found on most of the houses in Doubs, the modern siding is also representative.

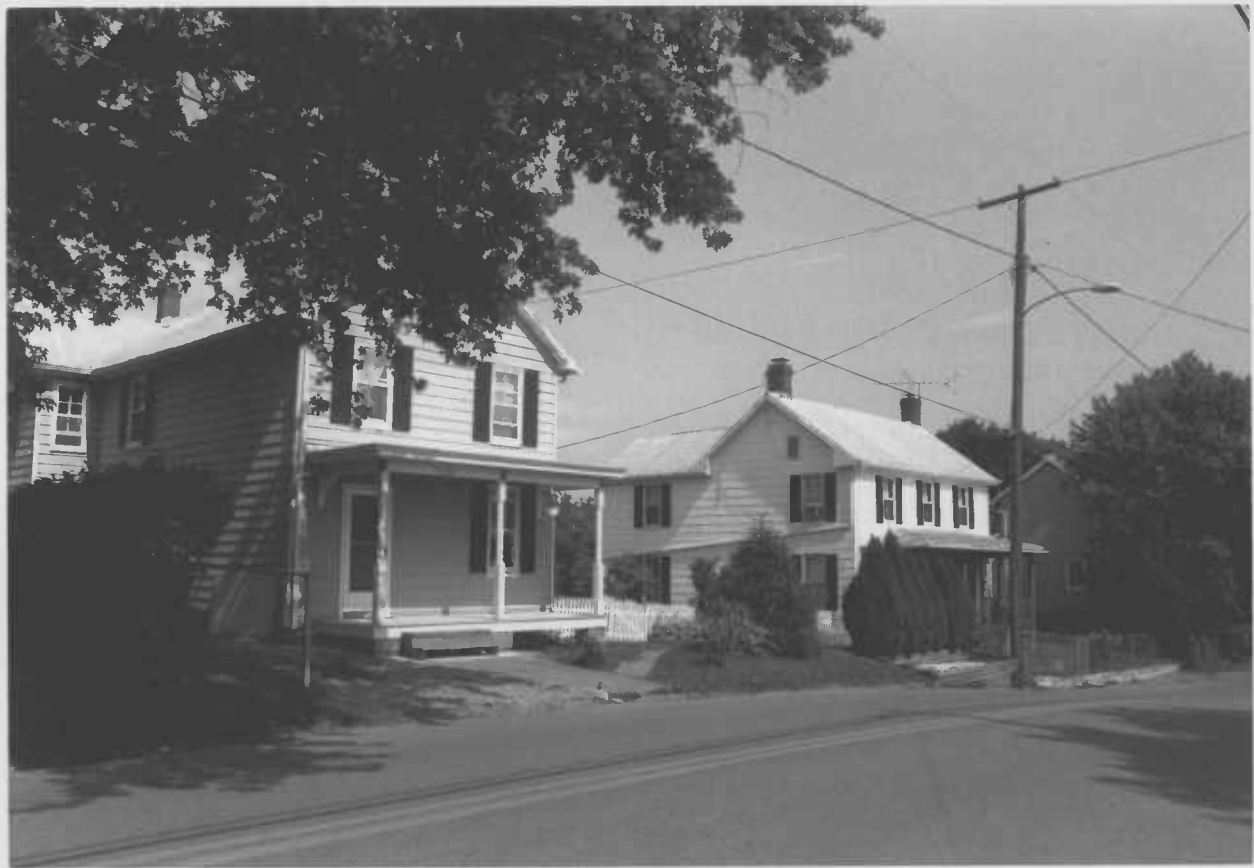
15/30

5138-5140 Doobs Rd. southwest elevation

5138 - F. 1-105

Jacob Kline House, 5138 Doubs Road (F-1-105): The Jacob Kline House is a two-story frame gable front and wing type dwelling. It has two bays and a one-story porch in the gable section. The exterior is covered with vinyl siding. The roof is standing seam metal. Spindle brackets which were in place in 1978 have been removed from the one-story porch. The sash is 2/2. The gable section has a round-arched window near the peak. The house was built about 1900, probably by William Basford, who purchased the lot from Jacob Kline in 1899 for \$500.

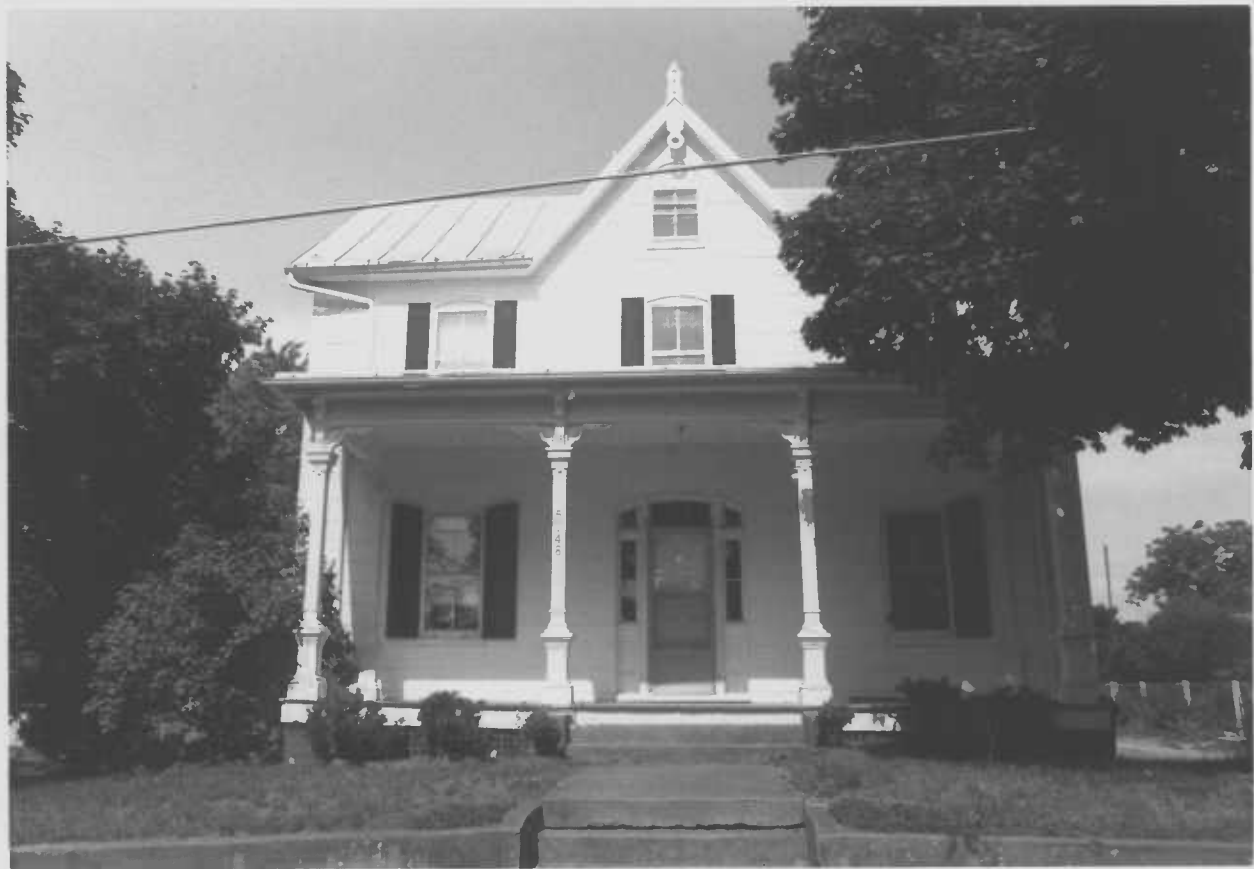
18/30

5148 Doubs Rd., Southwest elevation

Methodist Parsonage, 5148 Doubs Road (F-1-106): The Methodist Parsonage is a two-story frame cross-gabled dwelling with three bays and a one-story porch. The exterior is covered with asbestos shingle siding and the roof is standing seam metal. The center gable has a finial at the peak. The window and door openings have segmental arches with modern replacement shutters on the second story and original arched shutters on the first story. The windows are 2/2. The house was probably built about 1885 by William H. Michael, who purchased the lot for \$100 from Jacob Kline in that year. In 1899, the Methodist Episcopal Church, Middletown Circuit, bought the house for use as the parsonage, which it remained until 1985.

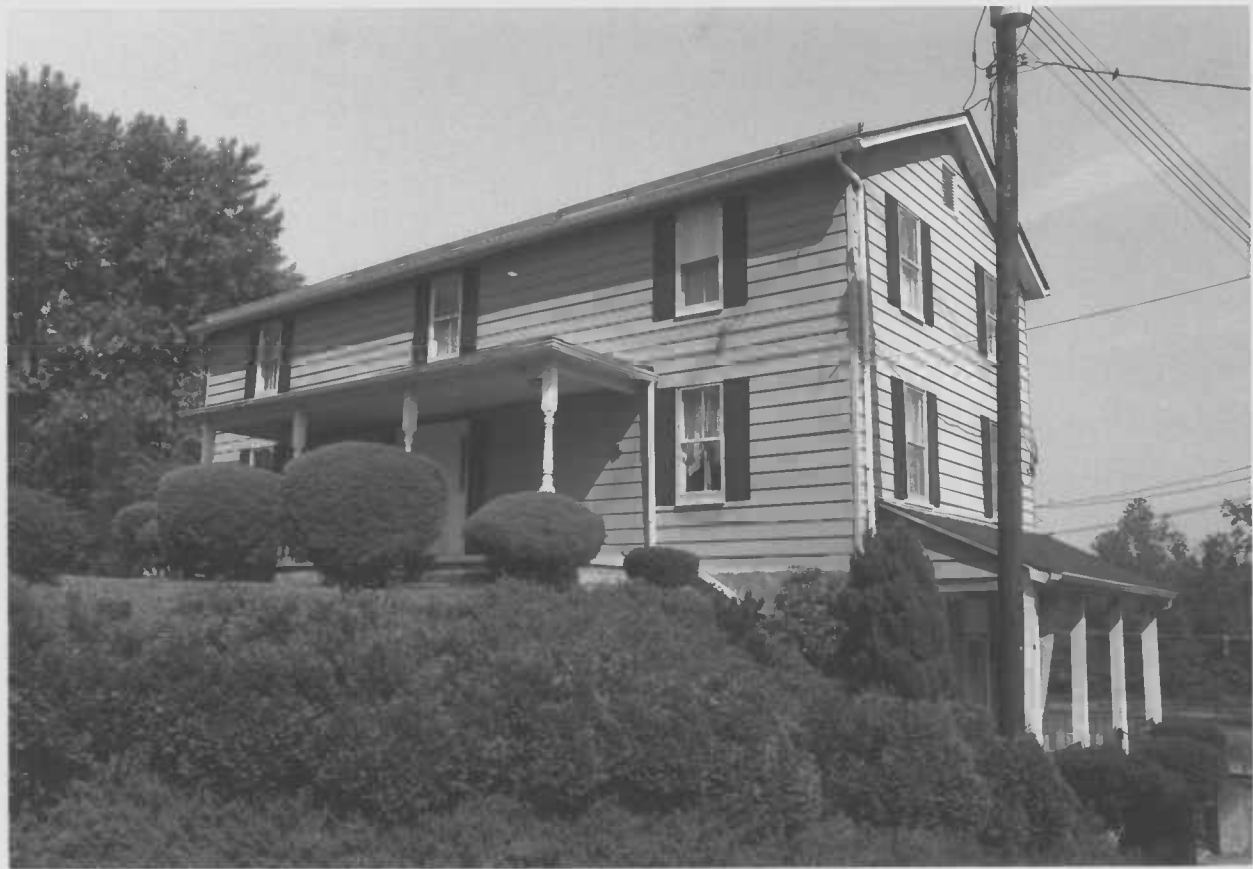
21/30

5160 Doubs Rd., Bastard Store, southwest corner
view

Basford's Store, 5160 Doubs Road: The three-story frame rectangular building is located on the north side of the railroad line and has a gable facade facing southwest in which the ground floor level, now converted to an apartment, retains the display windows of the store flanking the center entrance. The building has vinyl siding and replacement shutters flanking the 2/2 sash. On the west elevation, the building has two floors with a separate entrance and three widely spaced bays. A one-story porch covers the center bay. A shed porch shelters the former store entrance on the southwest. Jacob Basford probably built the store and residence about 1872. It remained a store until at least the 1950's. A circa 1948 photograph of the store by Walker R. Smith shows several advertising signs on the east elevation and a gas pump in front of the store porch.

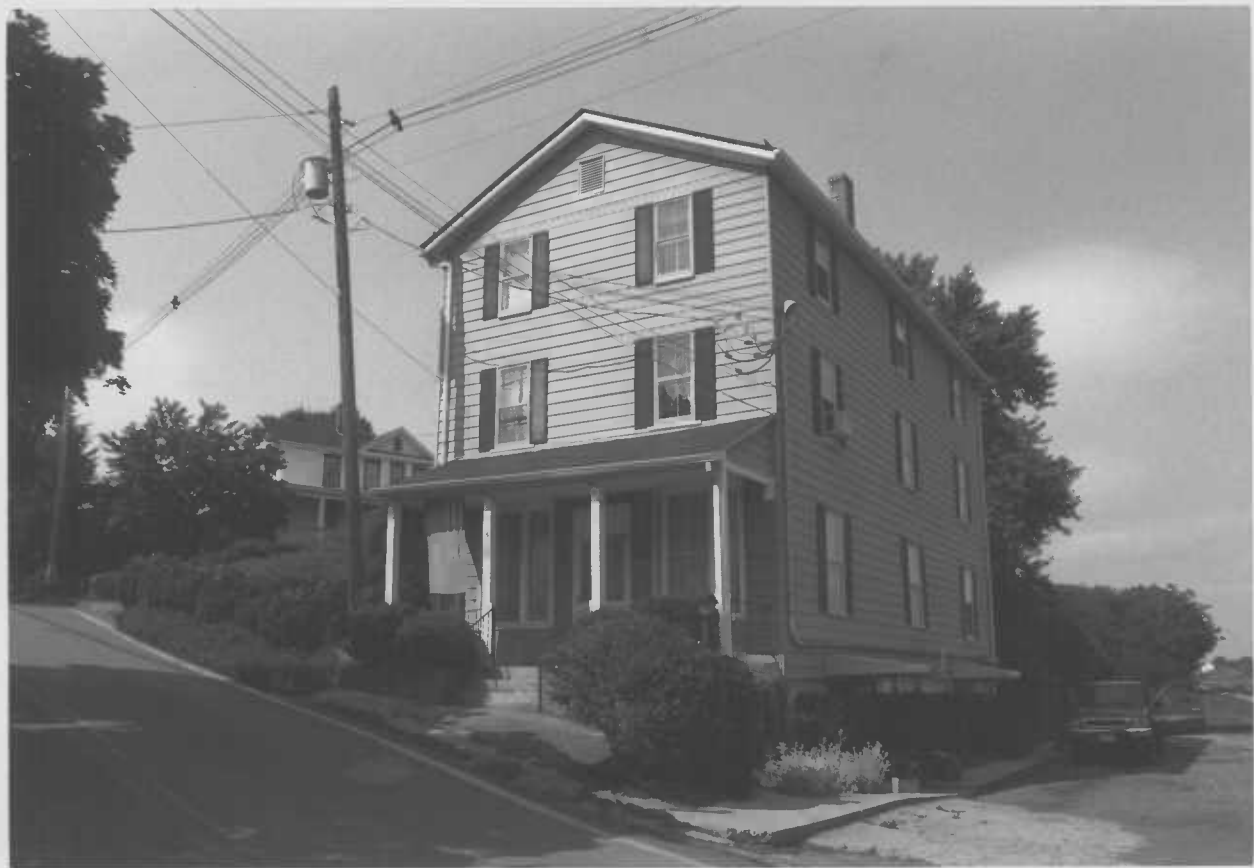
22/30

5160 Doubs Rd., Eofford Store, southeast corner
view

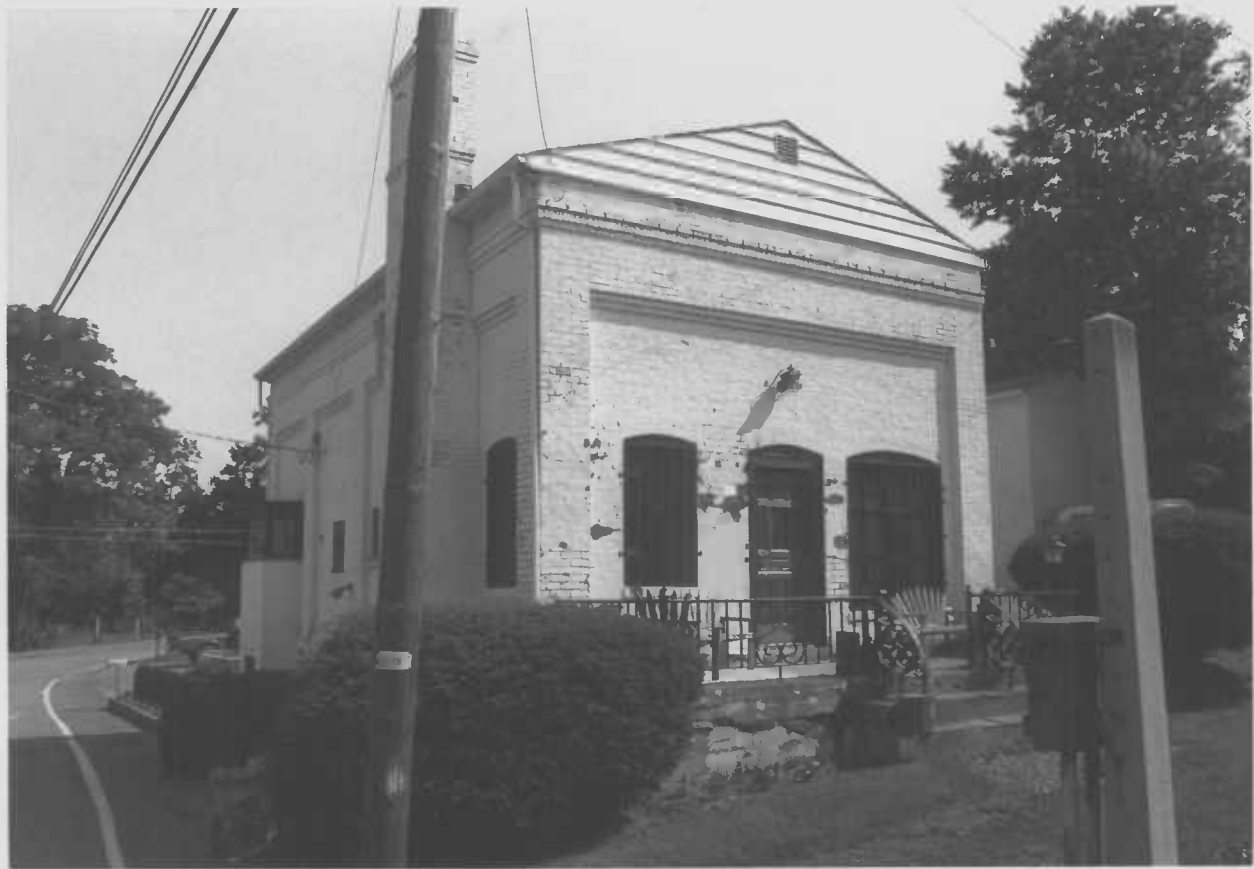
24/30

Hickman's Store, 5167 Doubs Rd. northwest

corner view

Samuel T. Hickman Store, 5167 Doubs Road: The 1-1/2 story brick building located immediately south of the railroad line was built about 1919 by Samuel T. Hickman to replace an earlier frame building which burned at least twice prior to the construction of the brick building. Hickman switched to brick to protect the store from a repeat of the disaster, according to local tradition. The building was originally a flat-topped one story structure with a parapet along the roofline on the north side facing the tracks. The walls have panels formed by corbeled piers. In the 1960's, a half story was added to the plan, indicated by window openings reduced in size on the south elevation. The building was converted to residential use in the 1950's. It currently has modern windows covered with iron grilles and its interior floor plan has been obscured by modern work. The massive brick walls are on a stone foundation, which is revealed on the east side, with access to the basement. A projecting base with a modern bay window at the first story was intended to be a chimney, but was converted to a window. Hickman's store carried pianos, organs, sewing machines, and "vehicles of every description", according to Williams & McKinsey's History of Frederick County (1910).

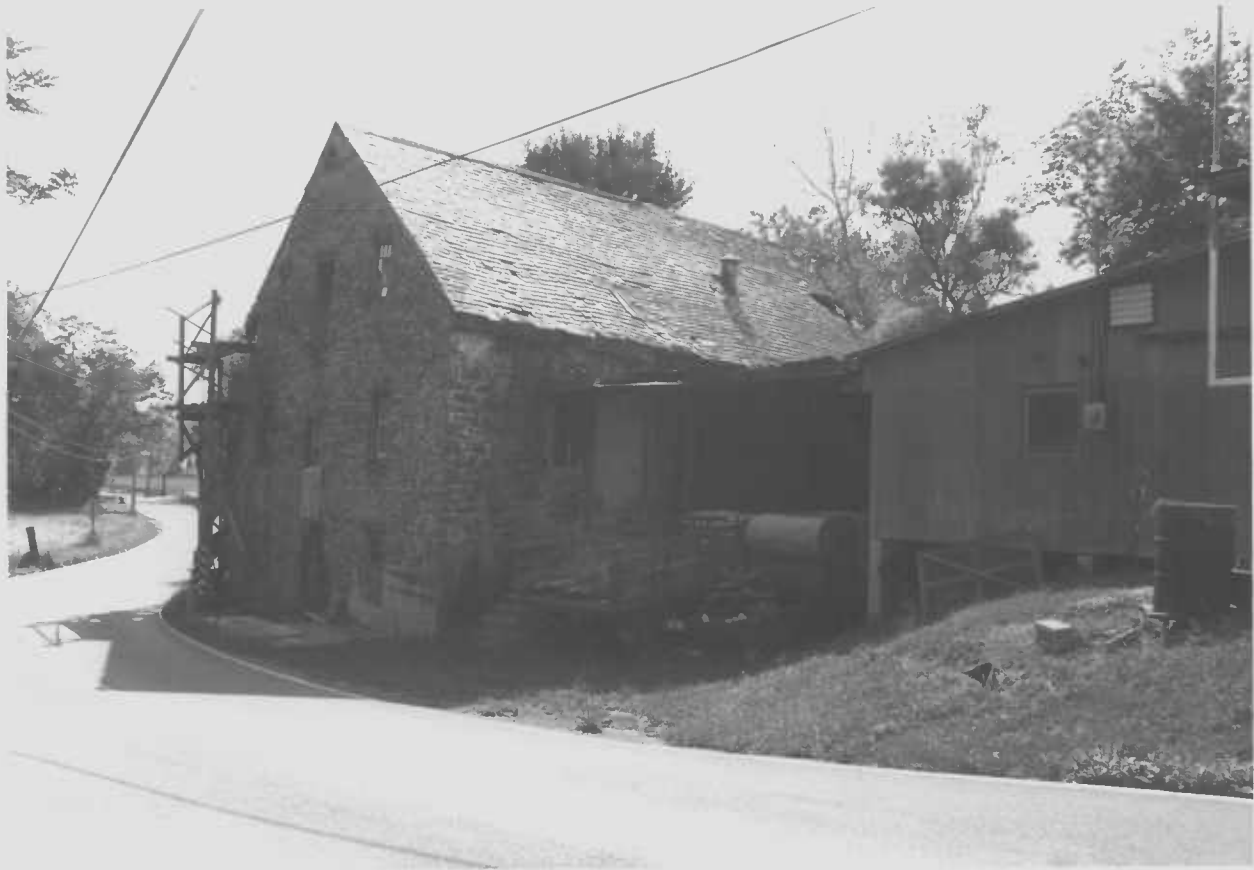
26/30

Neg. loc.: Md. SHPO, Crownsville, Md
Cottrell Mill (F-1-5) view from north

Carroll Mill (F-1-5): The three-story stone mill is dated 1812 in a stone near the door in the southeast gable end. It is located at the edge of Pleasant View Road and has a deteriorated frame building covered with metal siding adjoining it, a structure built in the early 20th century linked to the stone building by an open shed roof. The gable roof of the mill is covered with slate. The window openings are gauged brick. The sash is greatly deteriorated and is of varied types, including 6/6, 2/2, and 1/1. On the south side of Pleasant View Road are a row of frame garages, built in the early 20th century for the trucks used for deliveries

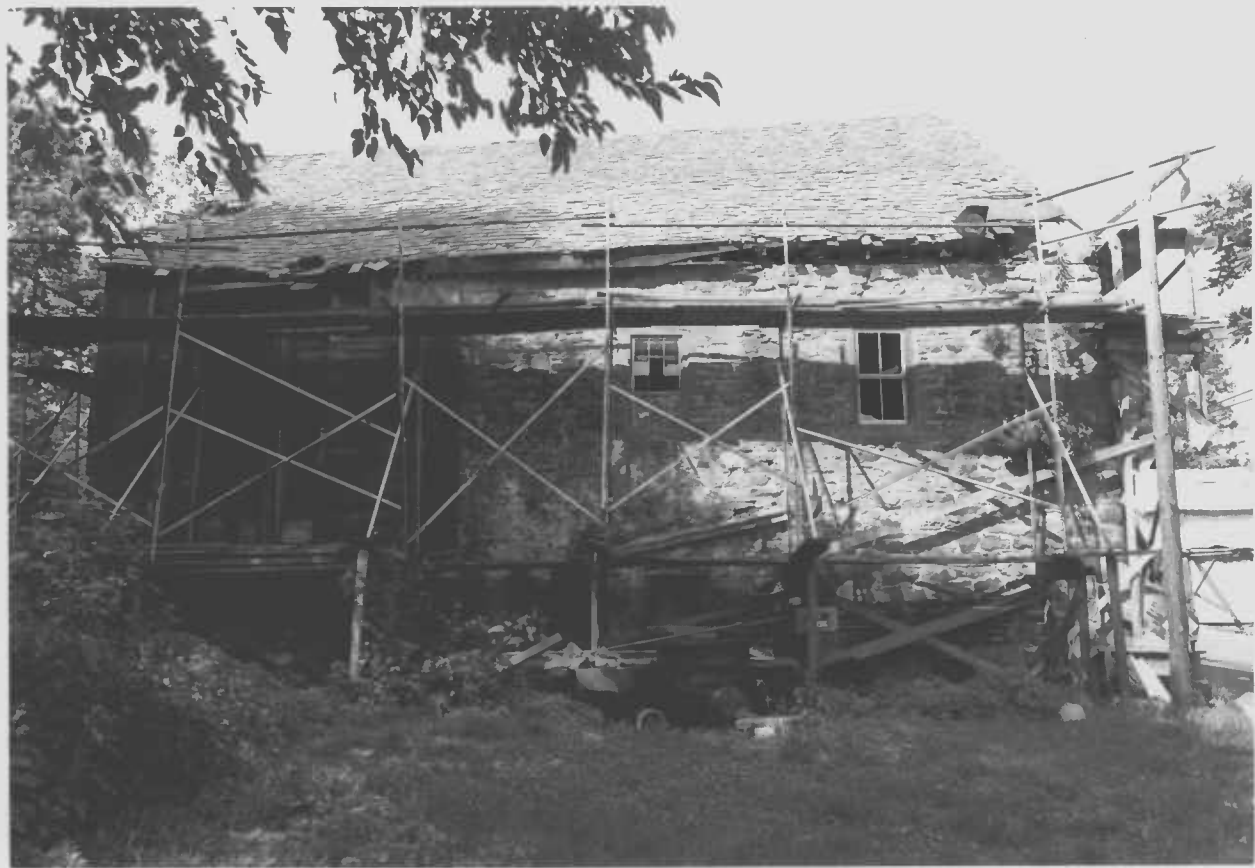
27/30

Corrall Mill (F 1-5), south elevation

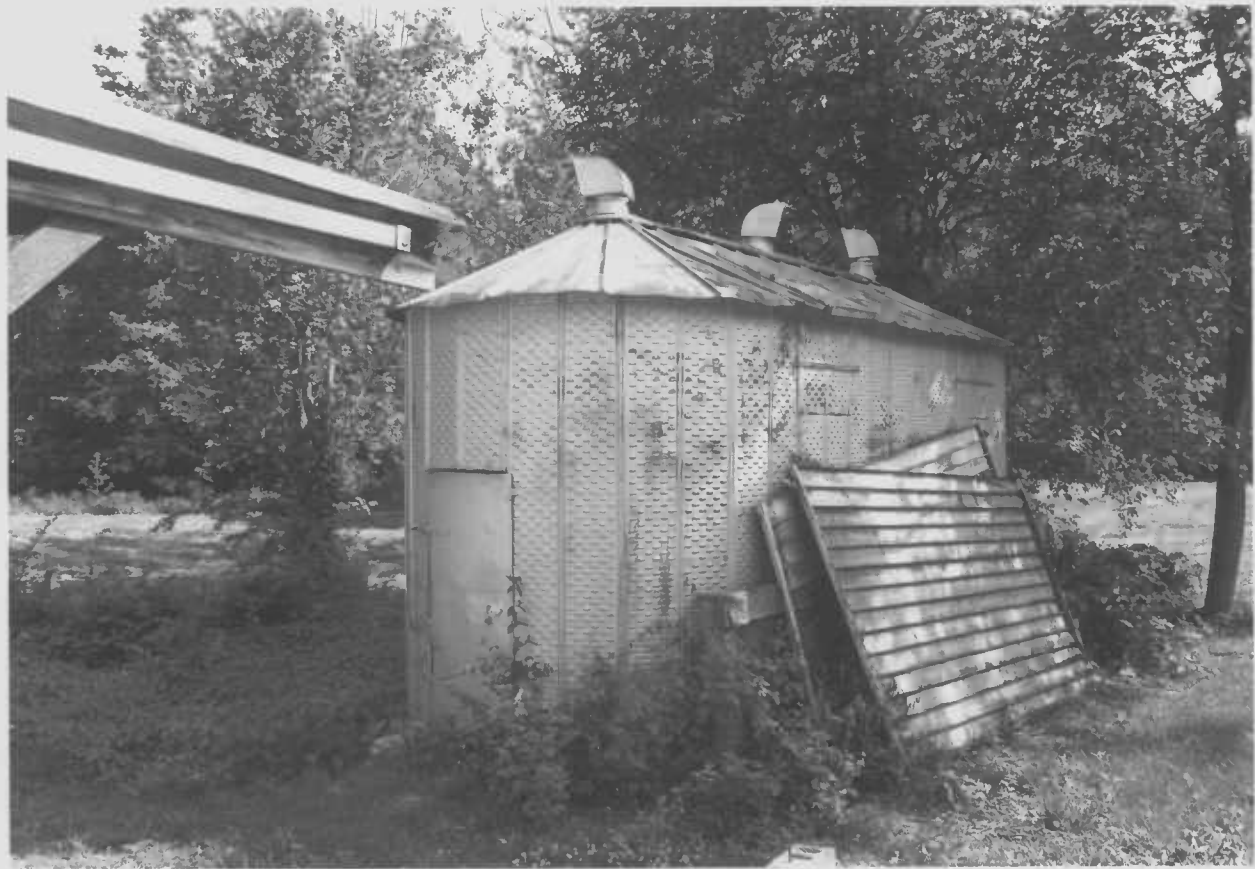
28/30

Corro. Mill (F-1-5), corn crib, view from
northwest

and for the Smith family's cars, they being the owners of the mill from 1905 to 1970. Directly across from the gable end of the mill is a rectangular perforated metal granary with rounded ends and a standing seam metal roof with a row of ventilators on the ridge. It was built in the early 20th century to store corn. Near the junction of Pleasant View and Doubs Roads is a historical marker describing the history of the mill. Built by Charles Carroll of Carrollton, it was operated by a succession of owners through the 19th century and up to the late 1940's when it ceased operation as a flour mill, continuing as a feed supply warehouse until the late 1960's. The dated stone has the initials J.S., who was, according to local tradition, J. Stonebraker, who first leased the mill from Carroll.

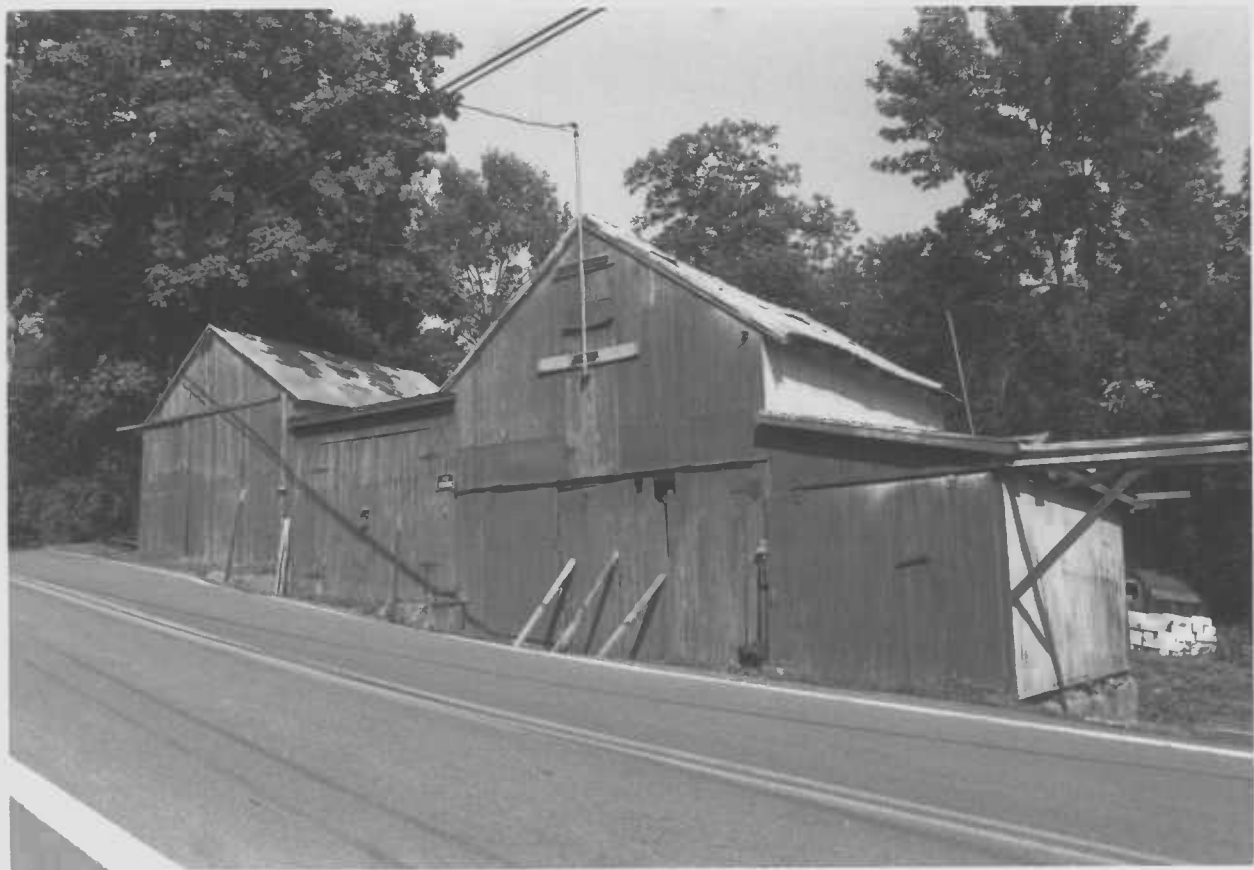
20/30

Corroll Mill (F-1-5), garages and sheds view
from south
